**NORWAY/UNITED STATES DESIGN PROTECTIVE
AIRCRAFT SHELTER (PAS) QUANTITY-DISTANCE
PROGRAM 1/3-SCALE TEST SERIES**

**Volume I of V
PAS 1-4 Summary**

Final Report

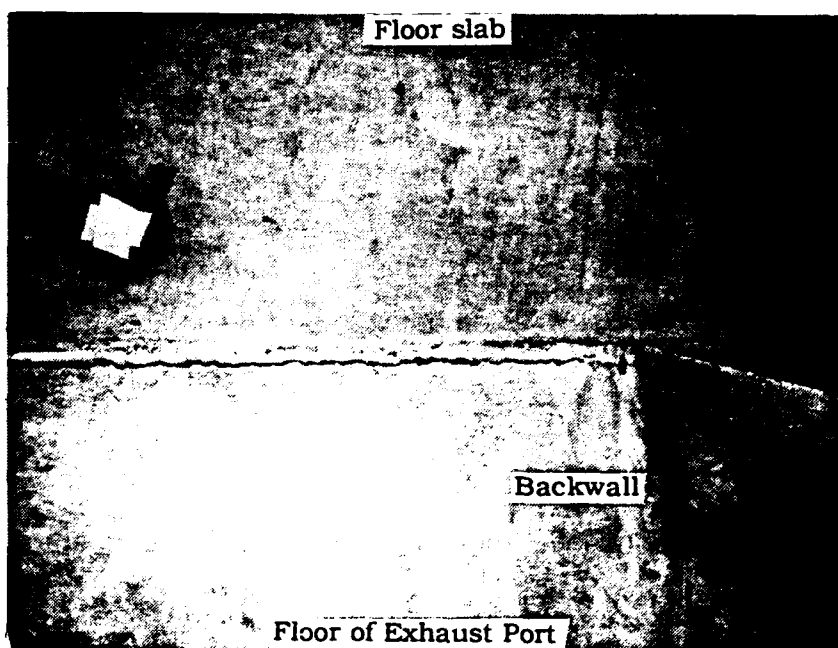
Figure 23. Gap between floor slab and floor of exhaust port, PAS-1.

A gap was noted between the floor slab and the backwall. The distance of separation ranged from zero at both of the back corners to 3 mm at the edges of the opening of the exhaust port. The gap continued across the opening of the exhaust port, at the joint between the floor slab and the floor of the exhaust port (Fig. 23). It had a fairly uniform width of 4 mm.

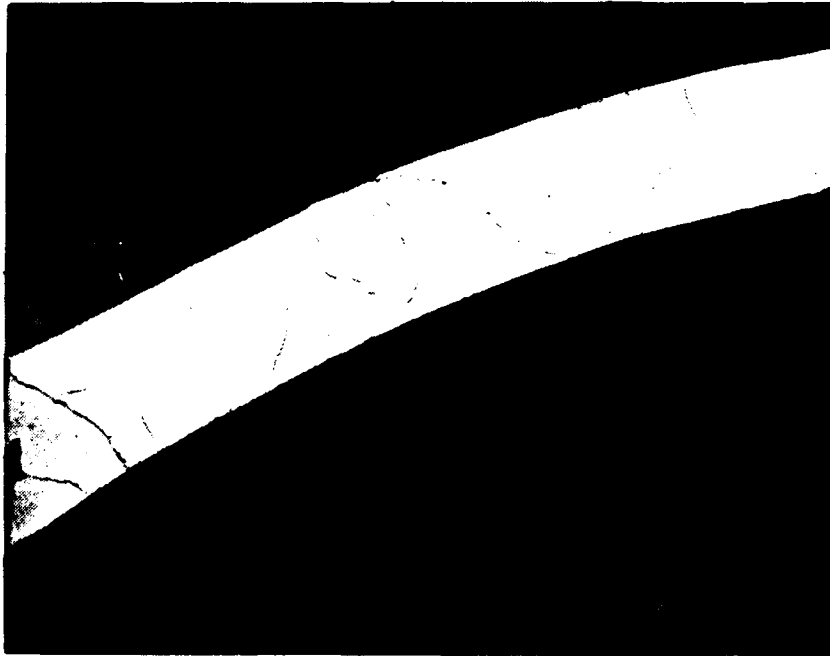
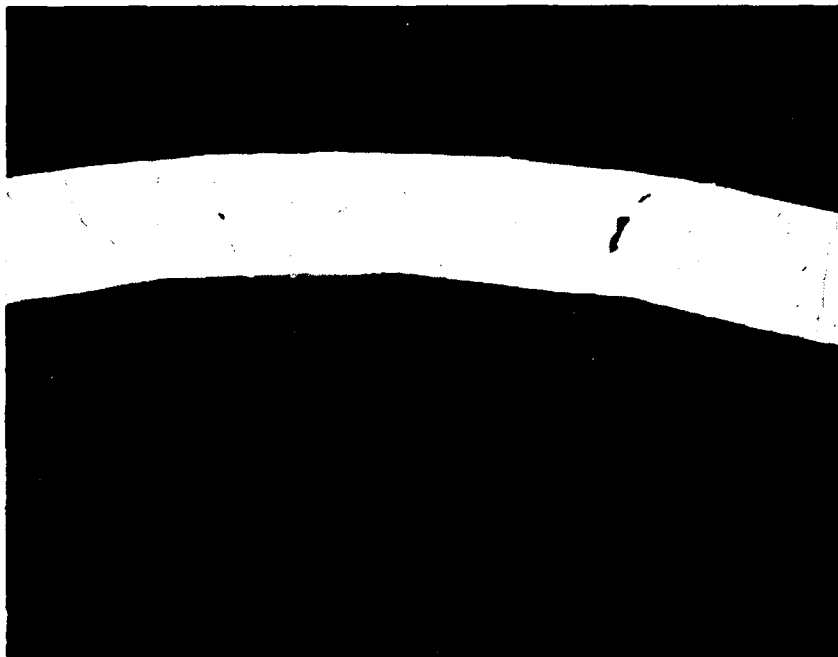
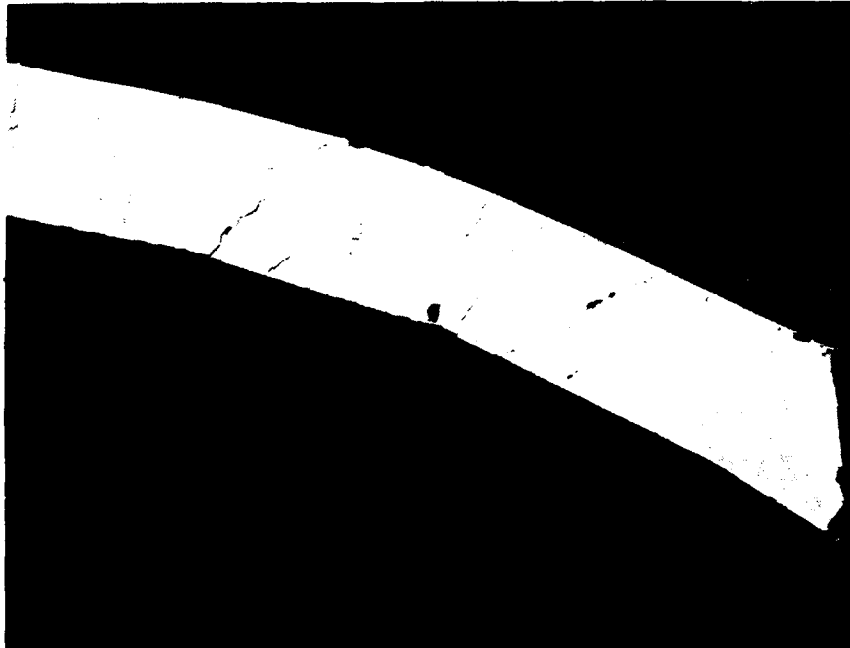
Figure 26. Crack pattern in face of parapet, PAS-1.

A series of hairline cracks could also be seen on the front face of the parapet (Fig. 26). As shown, the cracks near the top of the parapet were generally radial. Moving from the center toward the junction with the front walls, the cracks tended to become more diagonal. Although the crack pattern in the parapet seemed quite symmetrical about the centerline, it was judged that there was slightly more cracking and damage at the right side.

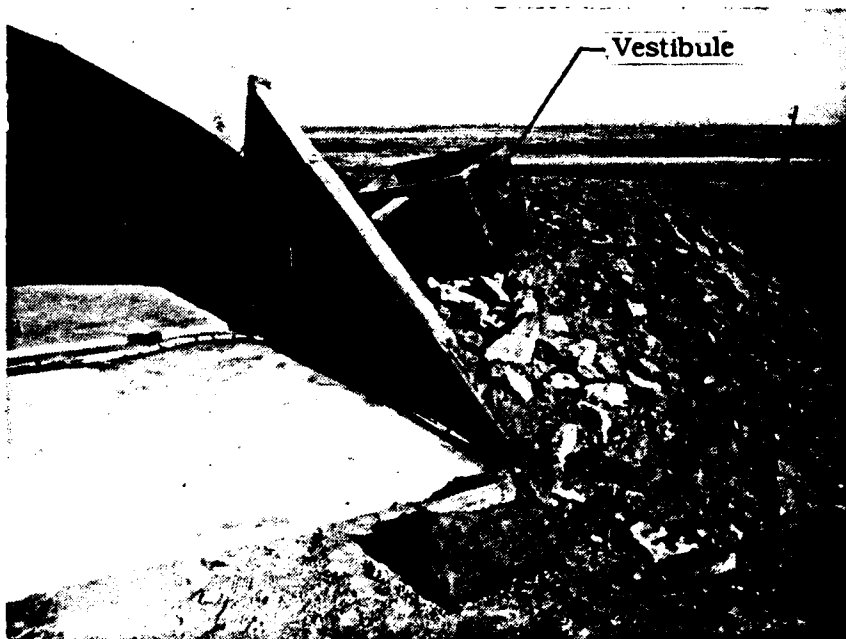
Figure 27. Posttest location of vestibule, PAS-1.

The personnel vestibule was found lying on the rock rubble berm within 1 m of its original position (Fig. 27). The personnel door that had been located in a frame installed in the opening in the left front wall was found inside the vestibule. The door had been bent outward about its vertical centerline, and the welds simulating the hinges and latches had all been broken. The door frame remained intact in the opening.

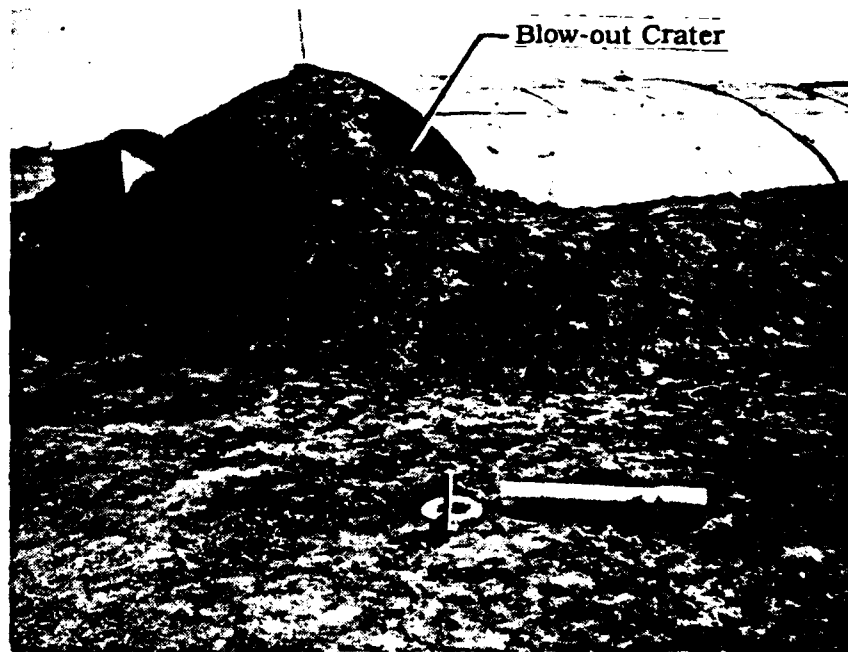
Figure 31. Pipe vent from backwall, PAS-1.

The polyvinylchloride (PVC) pipe vent located in a hole in the right side of the backwall was found lying on the ground approximately 5 m along a 45-deg line from the right, back corner of the shelter (Fig. 31). The remaining PVC pipe and T-fitting were found in a small blow-out crater in the earth backfill adjacent to the hole in the backwall.

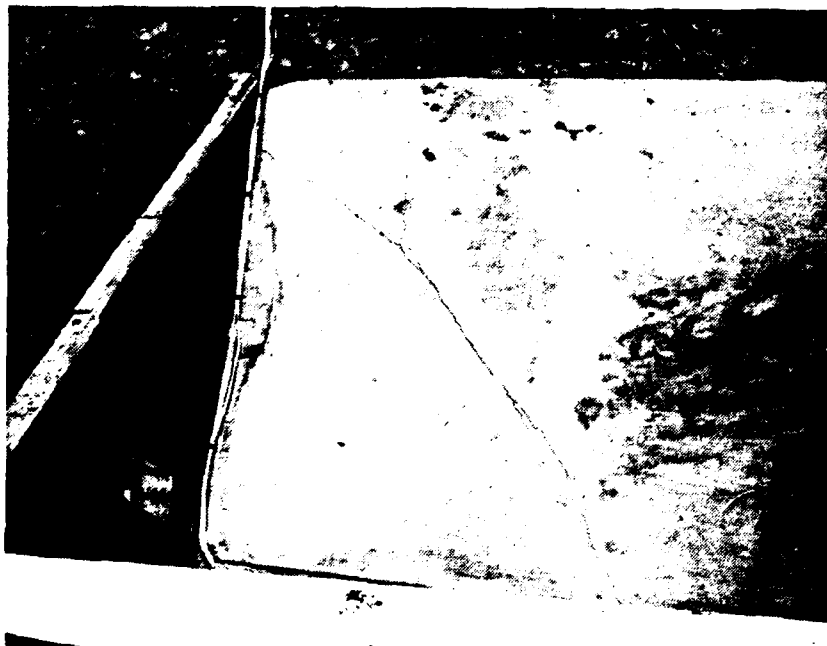
Figure 32. Crack pattern in left corner of the apron slab, PAS-1.

With the exception of a hairline crack in the left corner of the slab (Fig. 32), the apron slab at the front of the shelter was found to be undamaged. No cracking was noted on the right side of the slab. There was no separation or cracking between the apron slab and the front foundation of the shelter.

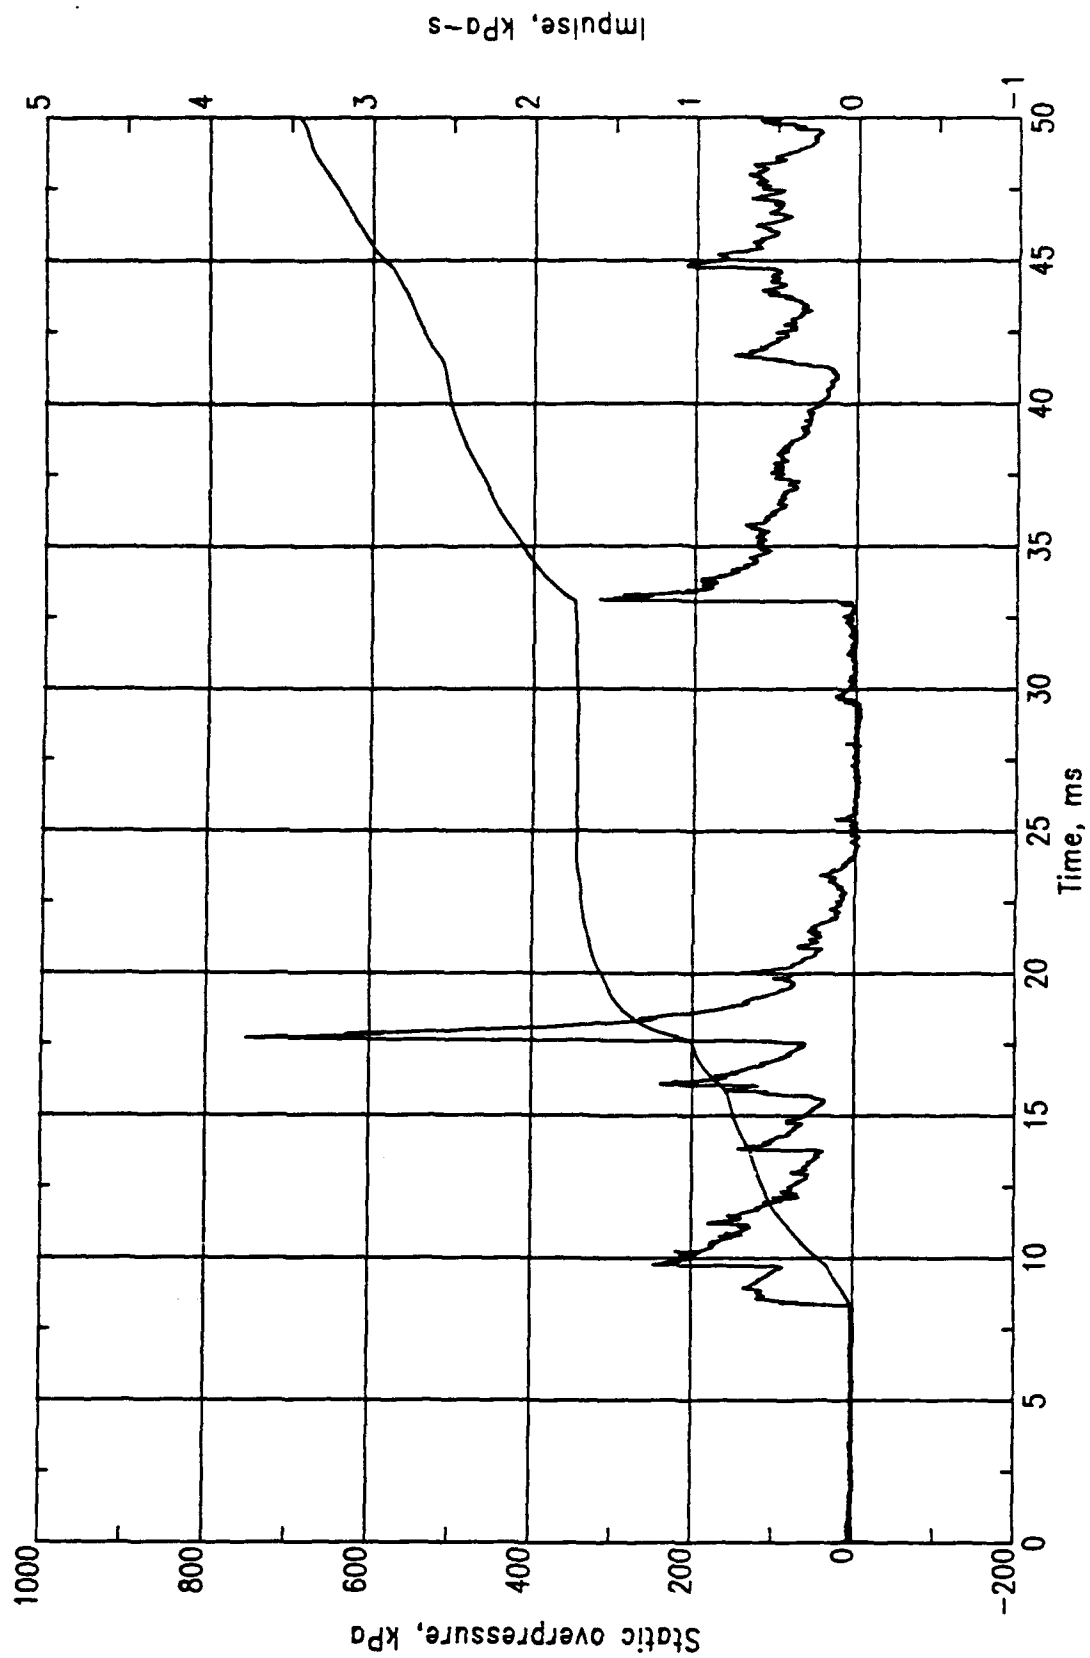
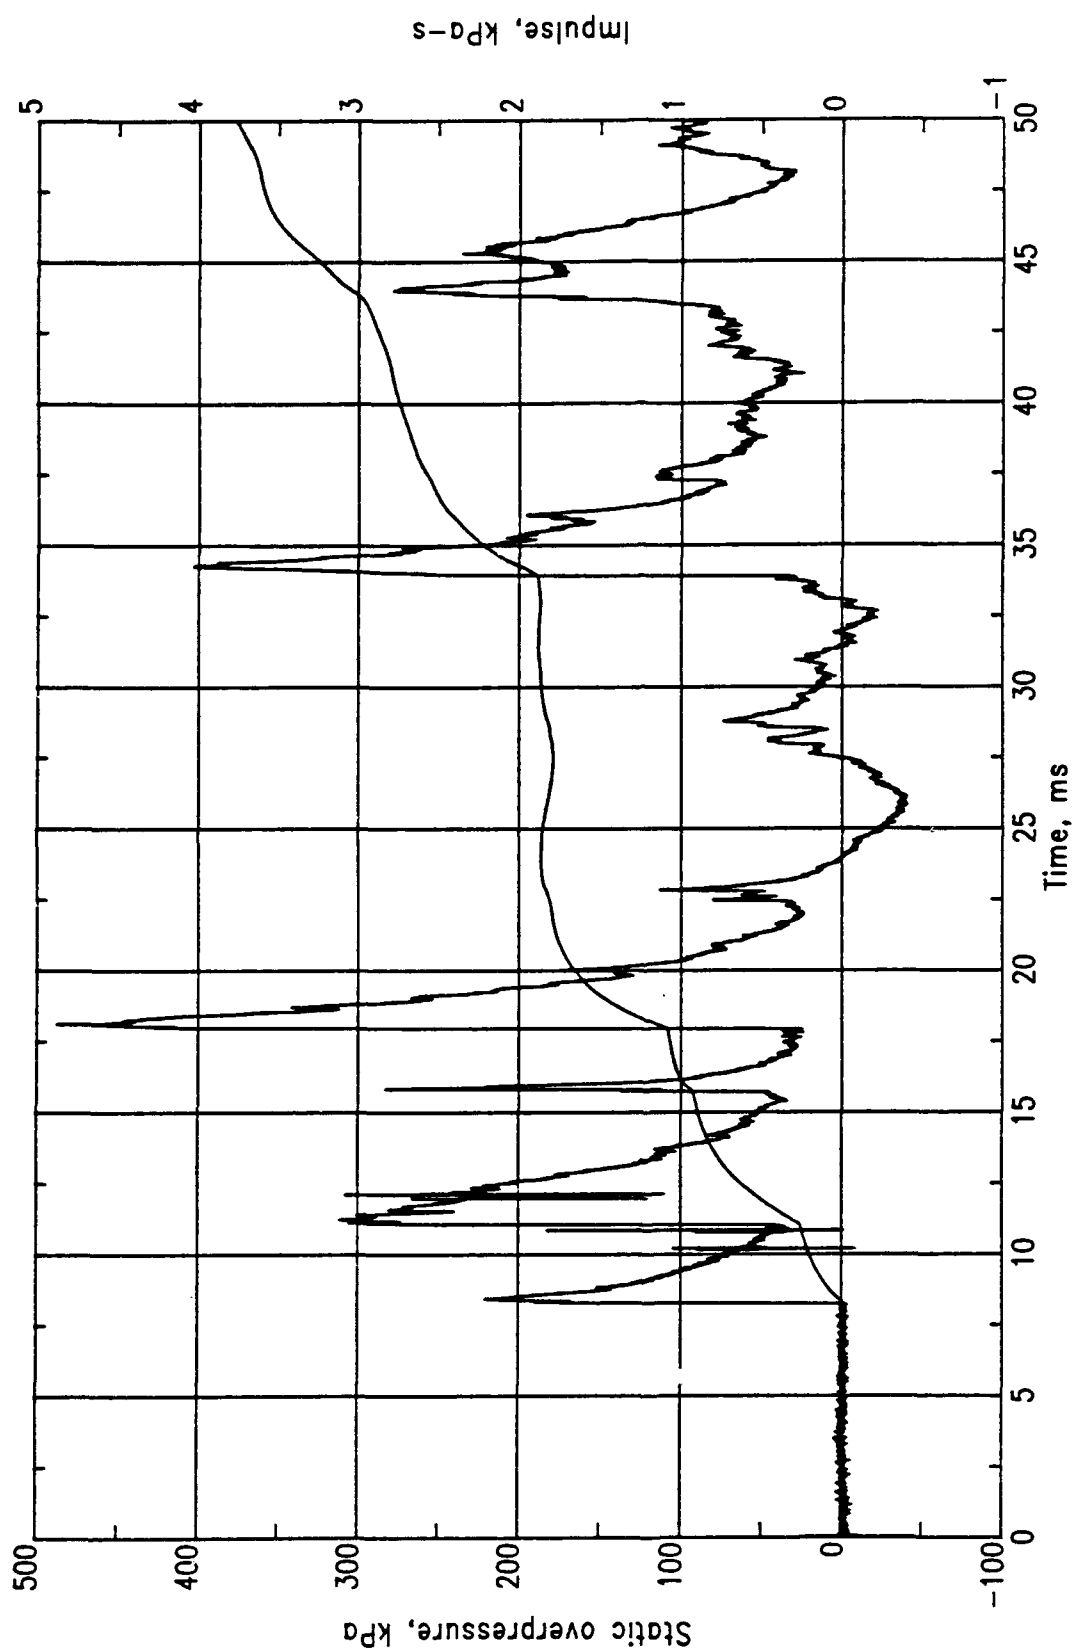
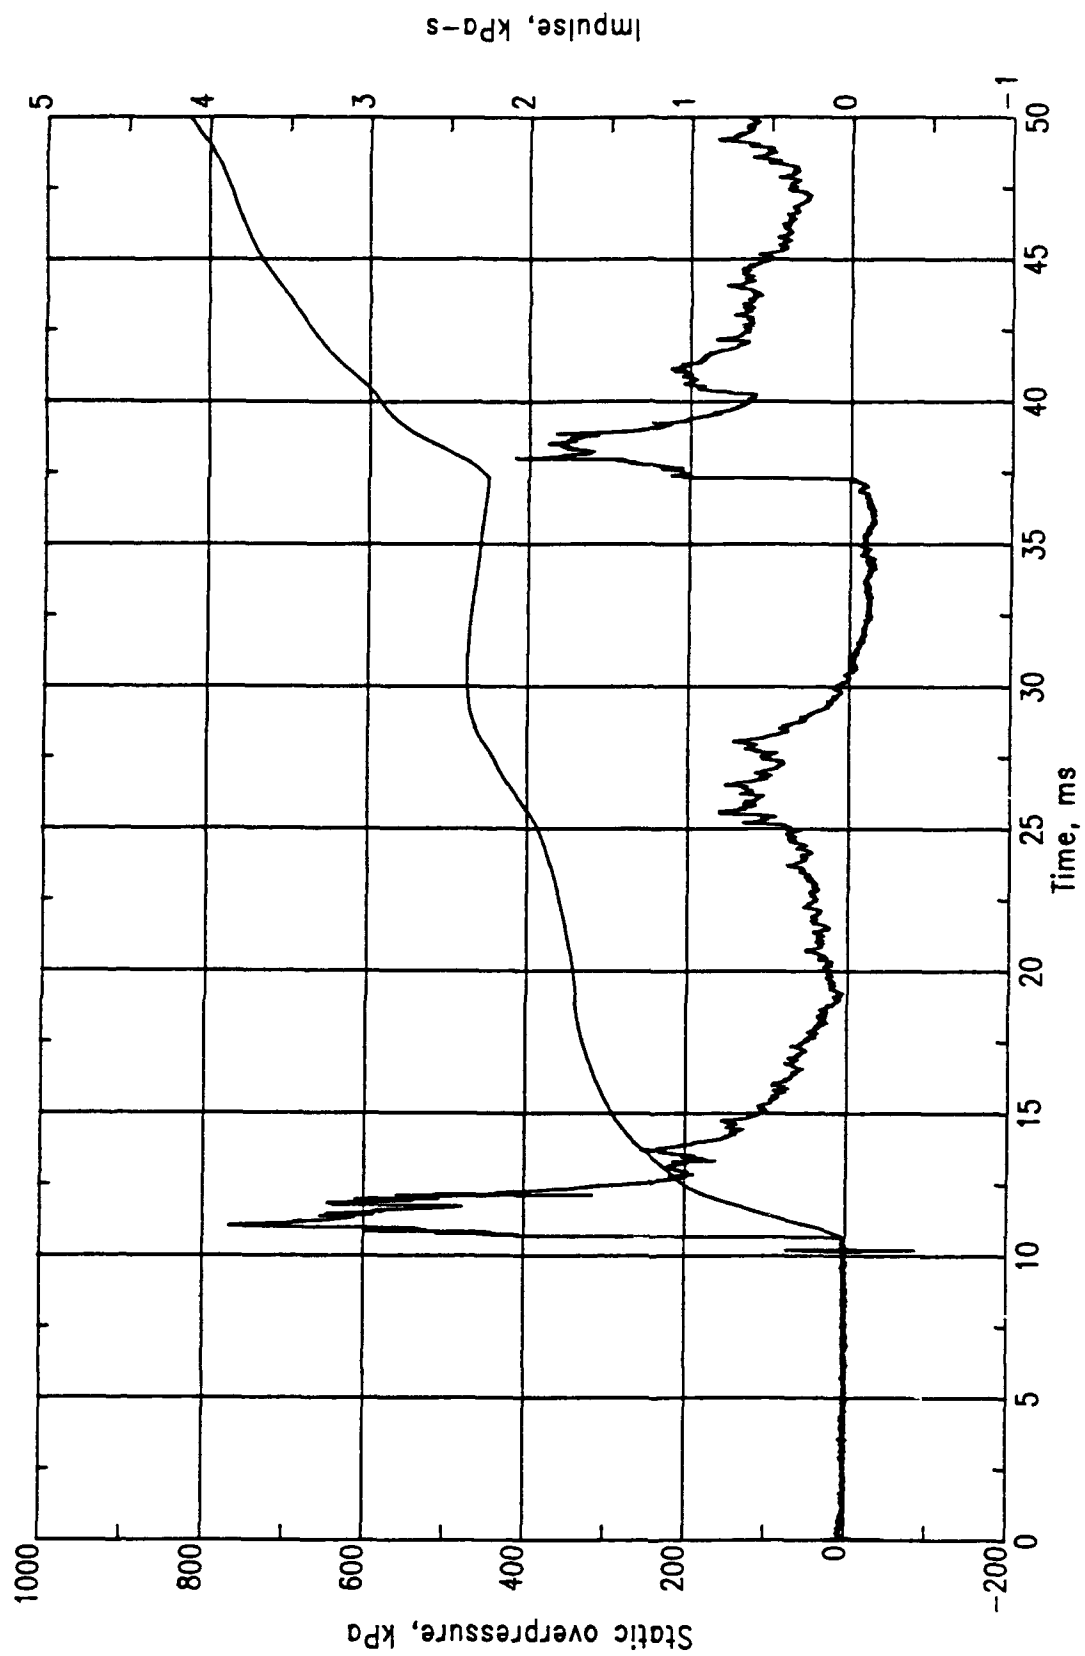
Figure 41. PAS-1, MN 0401.

Figures 41 through 43 show the pressures recorded at the inside centerline of the front door. The peak reflected pressures at the top, mid-height, and bottom of the door were 0.67, 0.76, and 0.49 MPa, respectively. These maximum values occurred between 17 and 18 m/s. The peak reflected pressure at the center of the door was predicted as 0.32 MPa at 9.5 m/s. The predicted value agrees reasonably well with a peak observed in MN 402 at about 9.5 m/s, but it is less than one-half of the maximum value that occurred at about 18 m/s. Measurement Number 405 made on the inner surface of the front wall near the outer edge of the door recorded a peak reflected pressure of 0.77 MPa at 11 m/s (Fig. 44) and showed no peak at 17 m/s. Measurement Number 404 failed at about 11 m/s and did not show the higher peak observed in the other records. A peak pressure impulse of 2.06 kPa-sec was predicted to occur at 54 m/s.

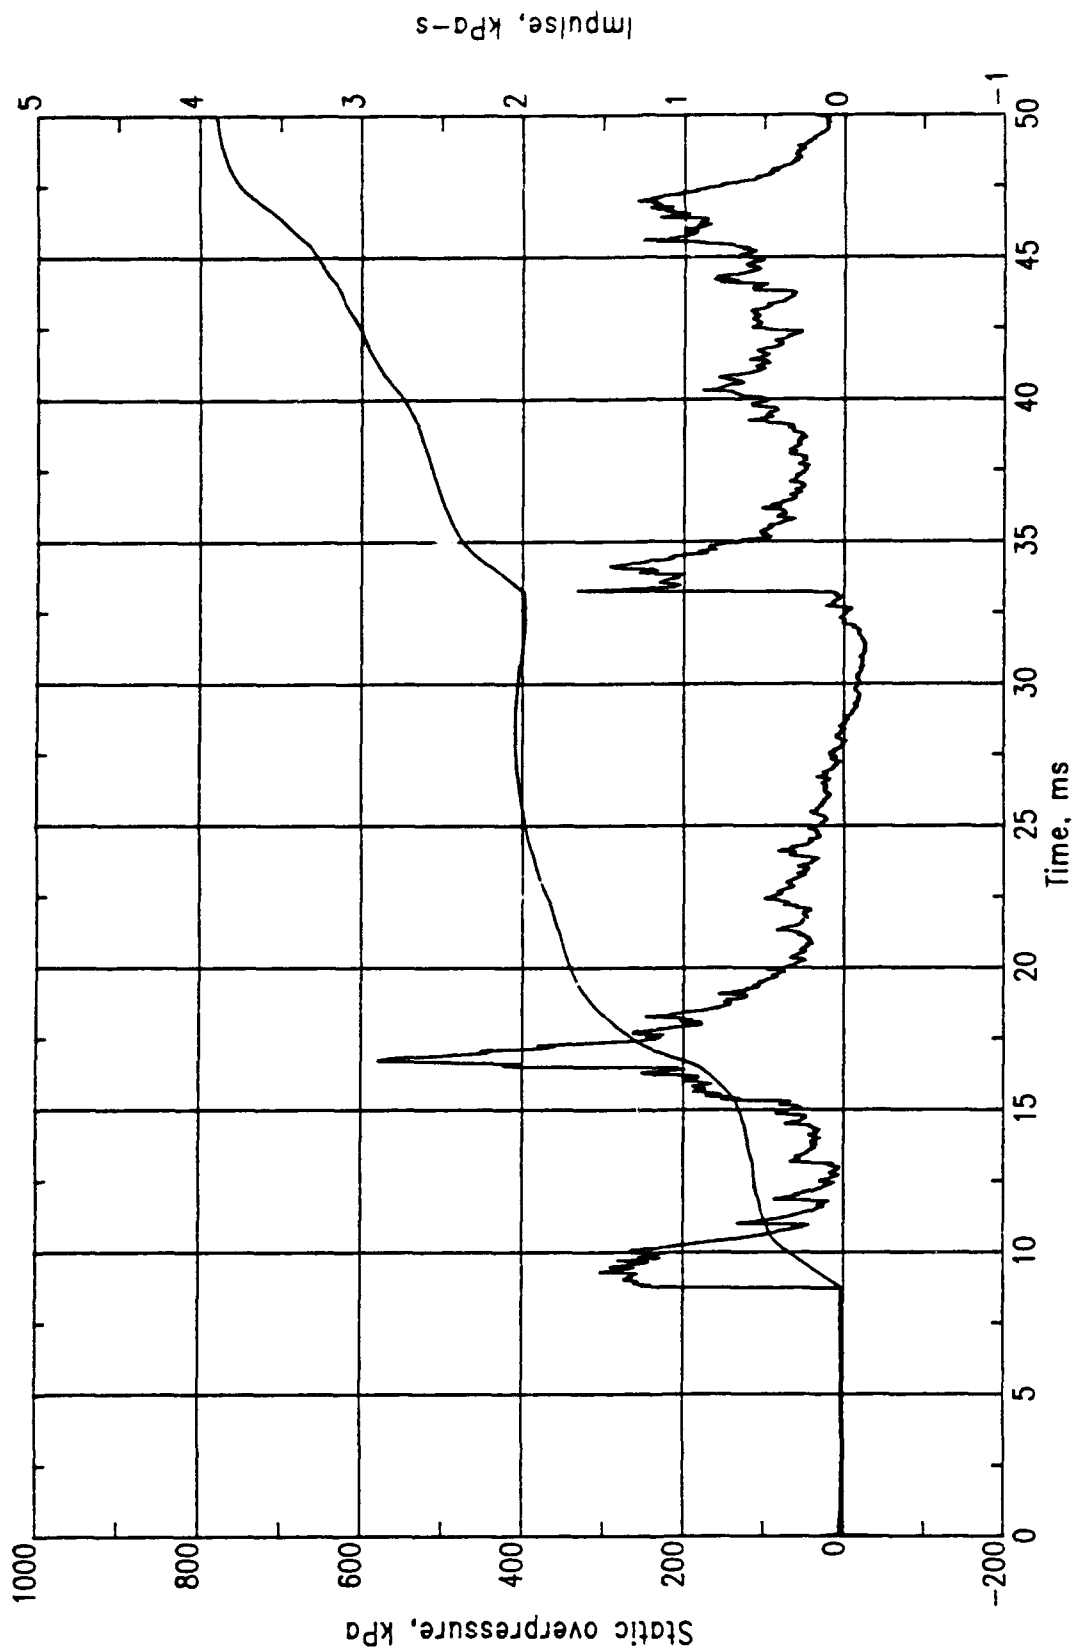
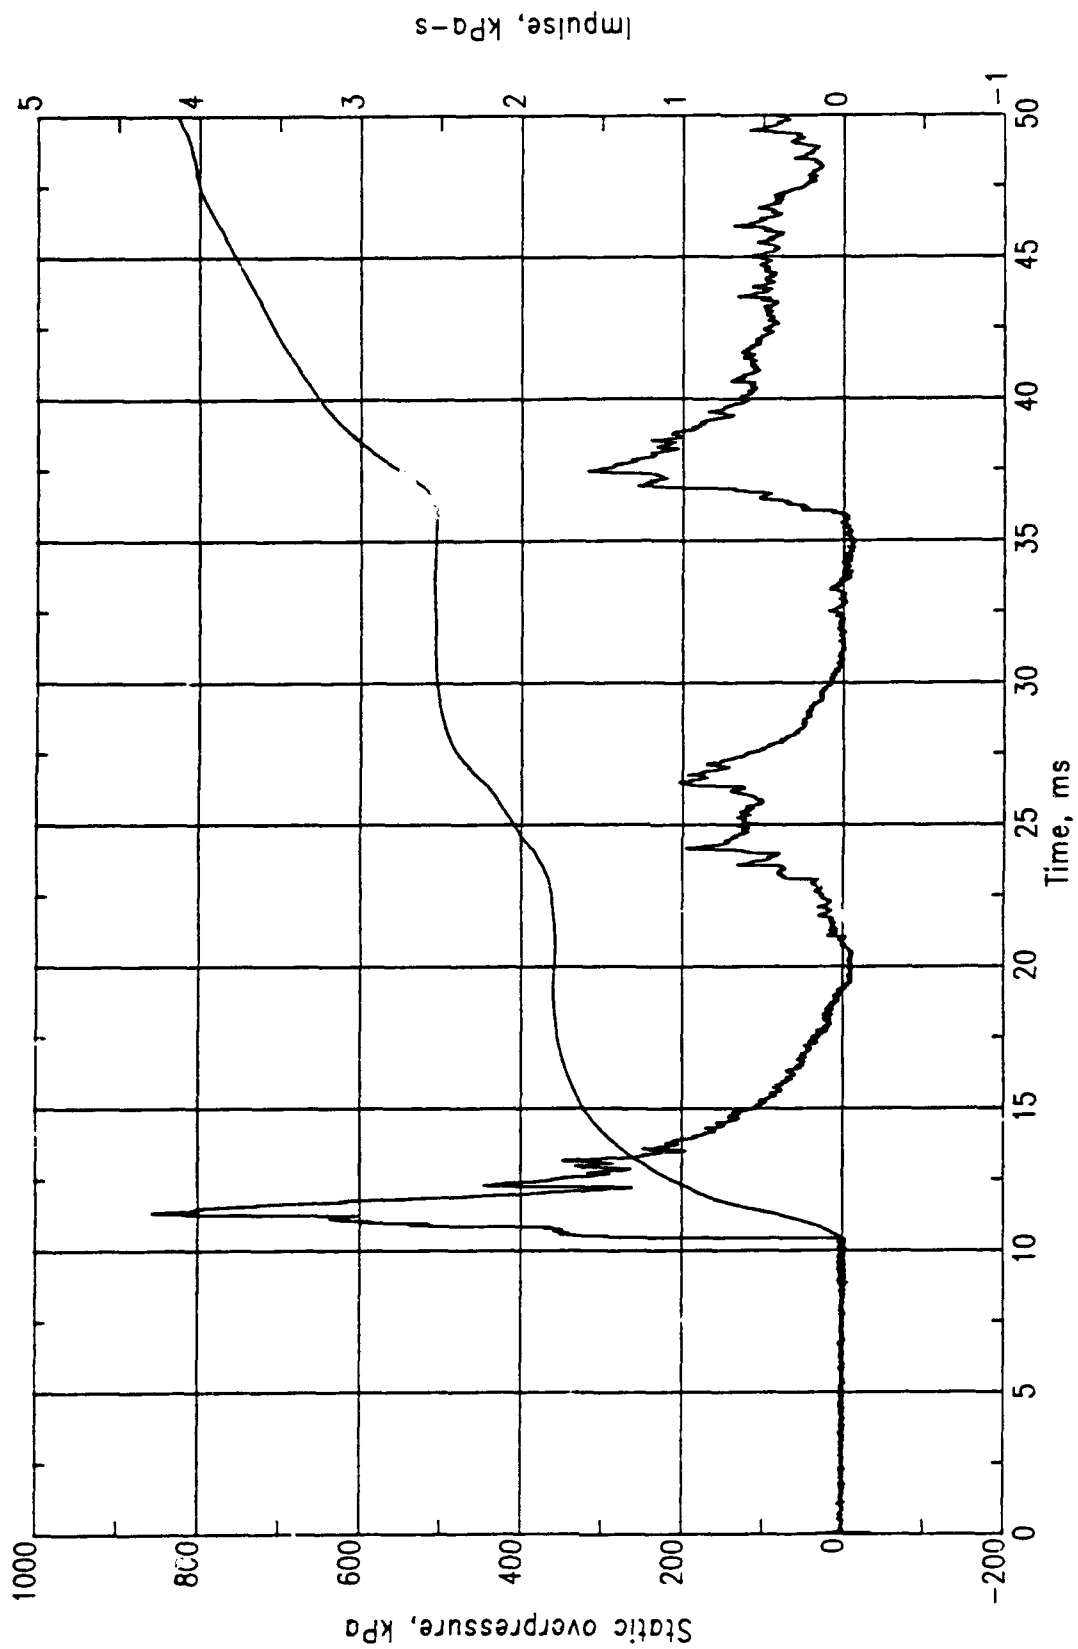
Figure 45. PAS-1, MN 0201.

character of the records obtained from MN 201 and MN 203 is similar to that of MN 401 and MN 405 (Figs. 45 and 46 versus Figs. 41 and 44). The maximum pressure peaks in MN 201 and MN 401 both occur at about 17 m/s; however, the 0.58-MPa peak of MN 201 is slightly less than the 0.67-MPa peak of MN 401. The maximum peaks in MN 203 and MN 405 occurred at about 11 m/s, but the 0.84-MPa peak of MN 203 is slightly greater than the 0.77-MPa peak of MN 405. Pressure impulse on the back wall was about the same as that on the front door. Since MN 404 failed, no comparison can be made between it and MN 202.

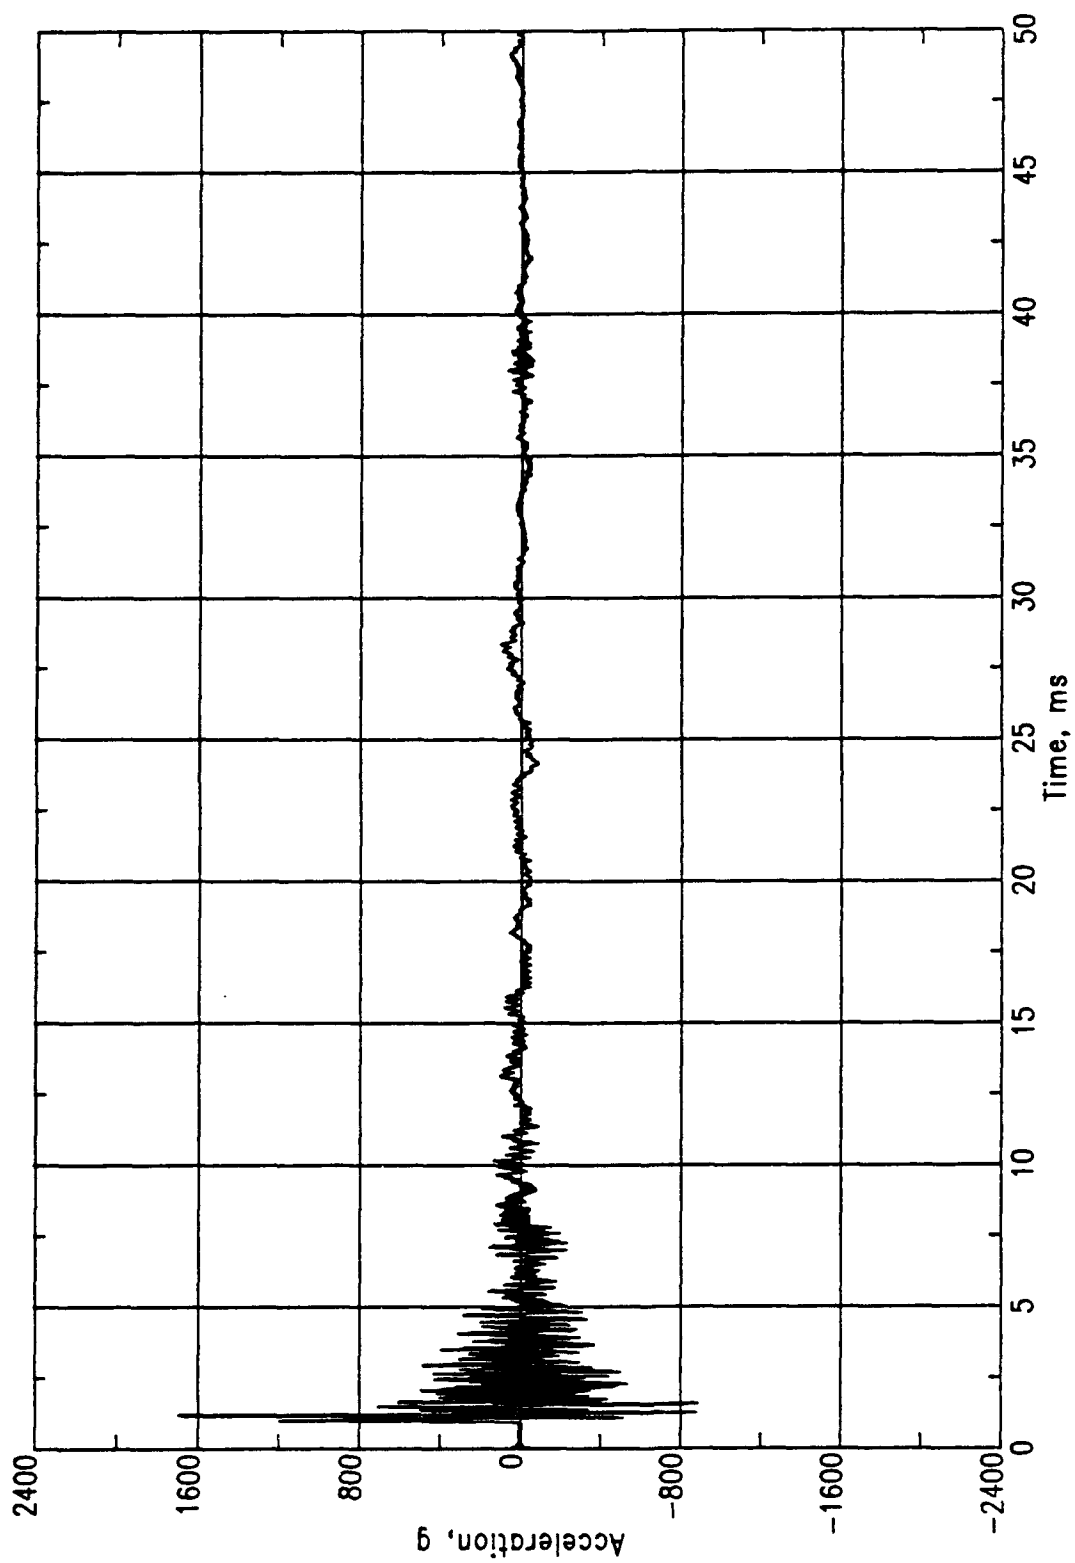
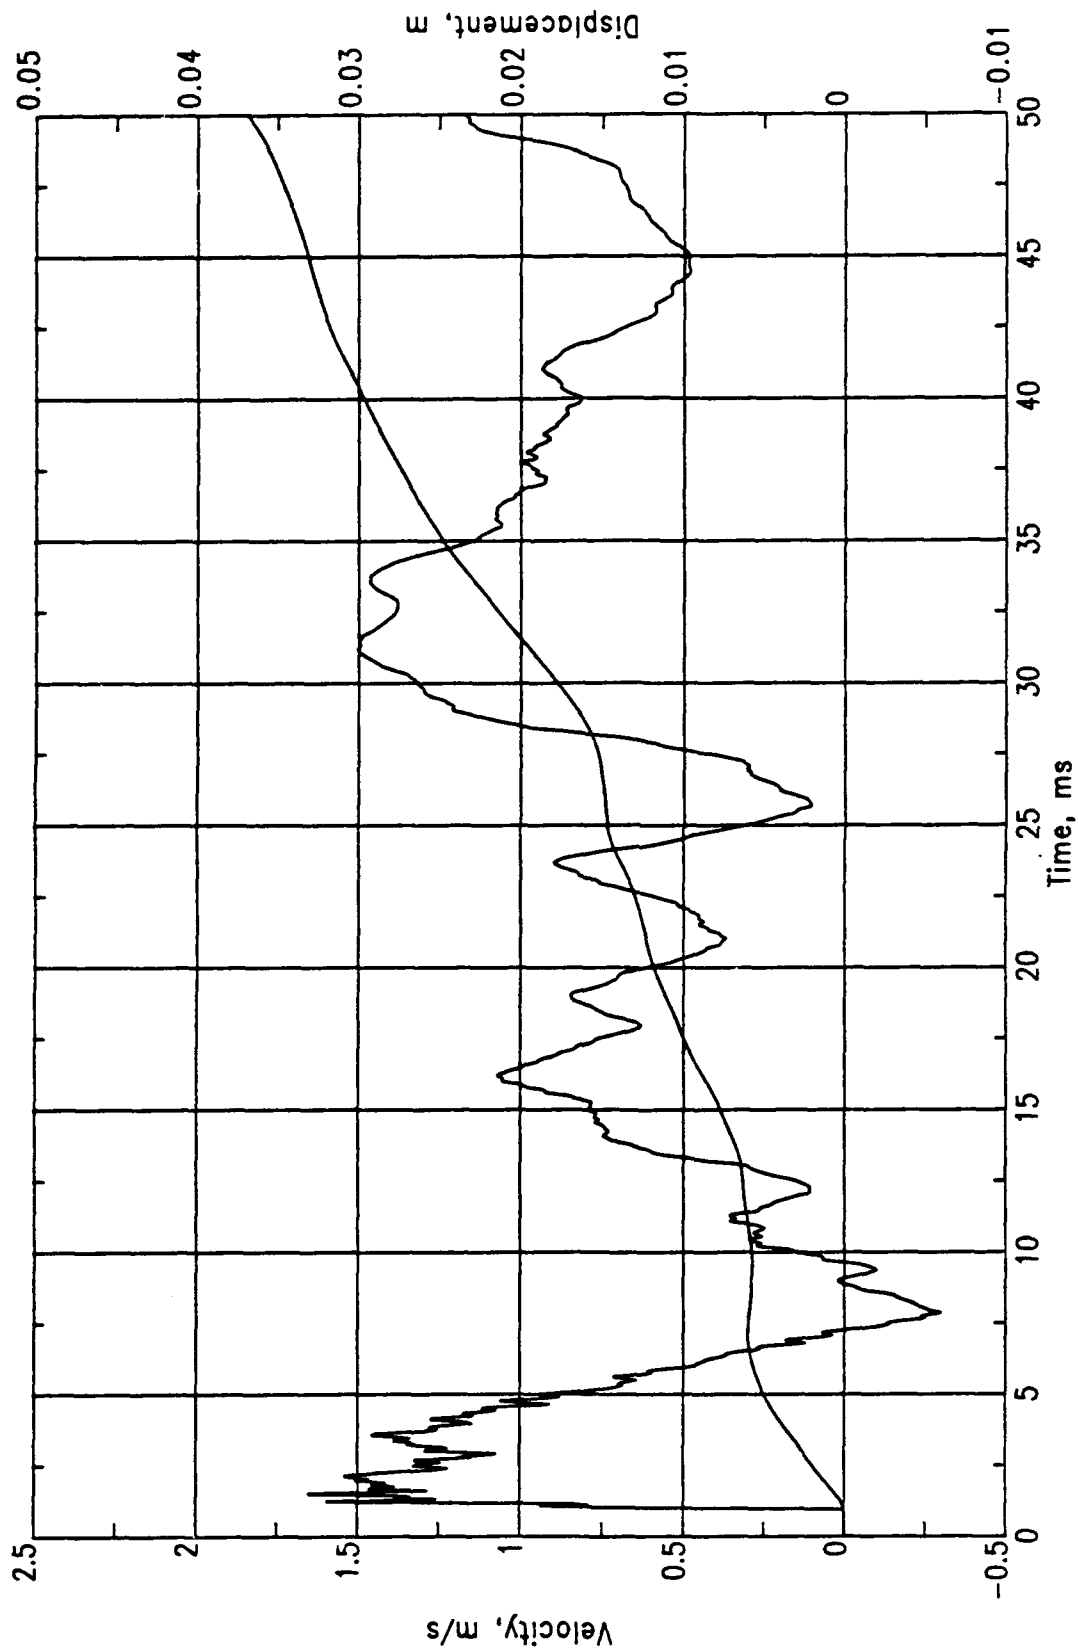
Figure 48. PAS-1, MN 1601.

Three pairs of accelerometers were mounted on the exterior surface of the arch in the same cross-sectional plane that included the GZ. The sensing axis in one accelerometer in each pair was oriented to measure radial accelerations; the sensing axis of the other was oriented to measure tangential accelerations. Measurement Numbers 1601 and 1602 were made at the crown of the arch directly above GZ. Figure 48a shows a peak radial acceleration of about 1700 g for MN 1601. Figure 48b, a plot of the first and second integrals of the accelerometer record for MN 1601, shows a peak radial velocity

of 1.70 m/s during the first 10 ms of the record. Figure 49a shows a peak tangential acceleration of -220 g for MN 1602; Figure 49b shows a peak velocity of -0.43 ms during the same period for MN 1602. Peak velocities given for times later than 10 ms are subject to greater uncertainties because of baseline shifts in the accelerometer records.

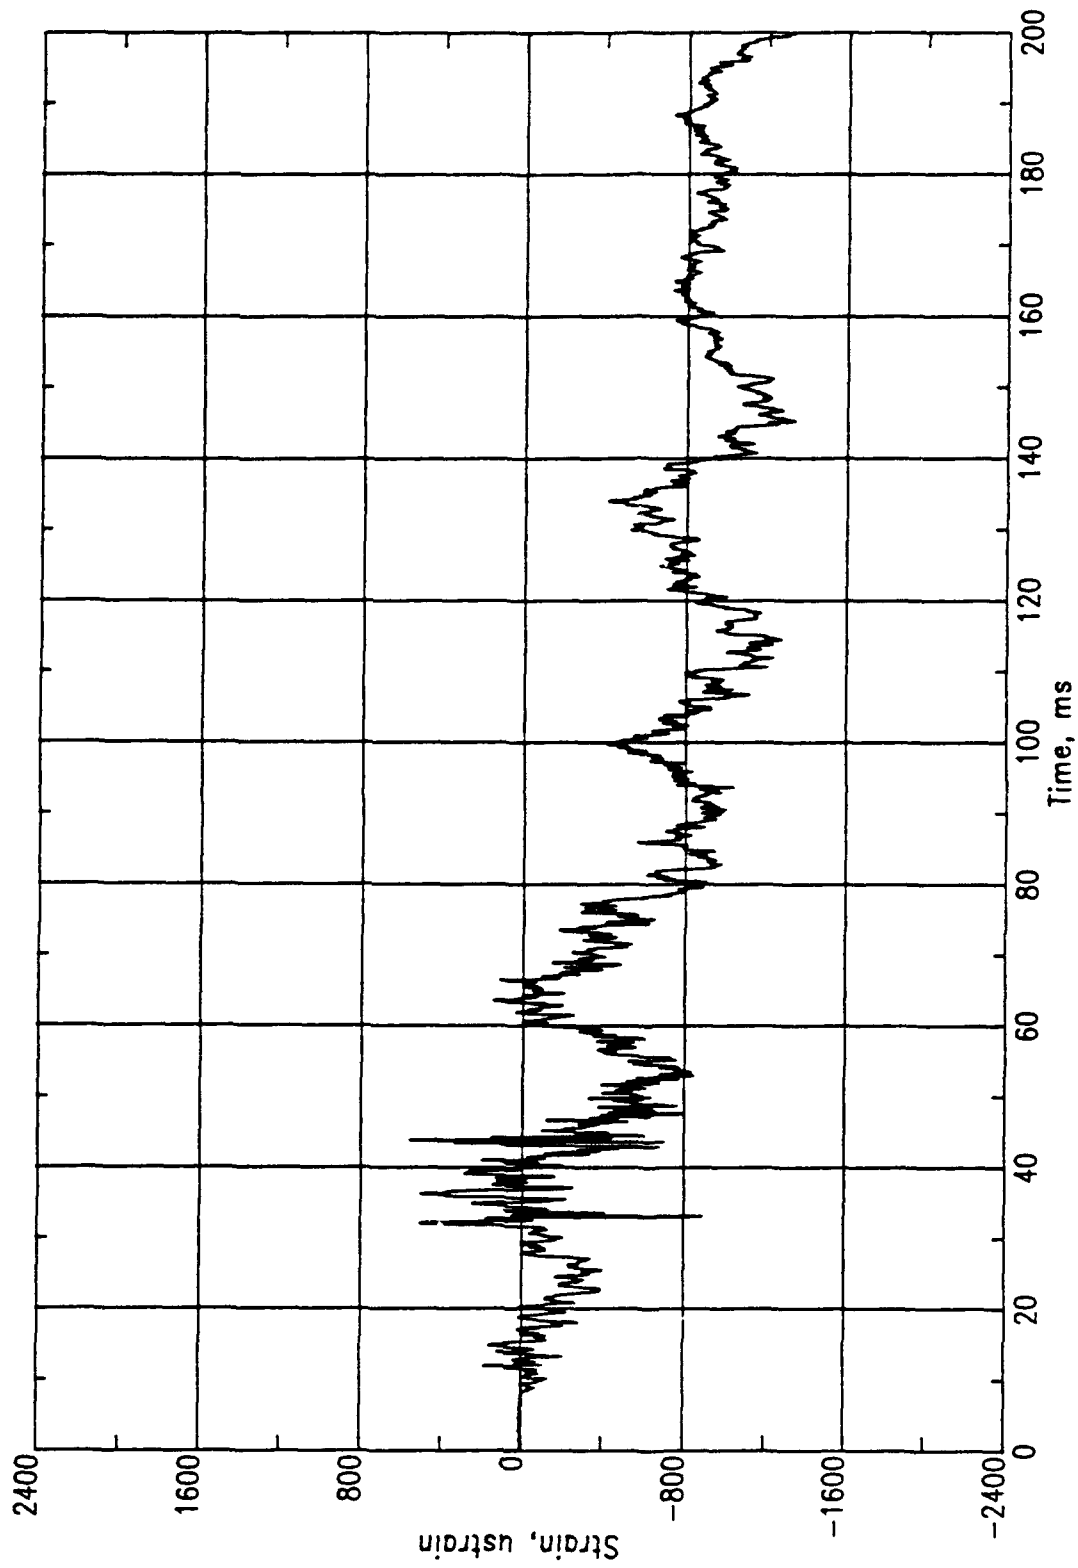
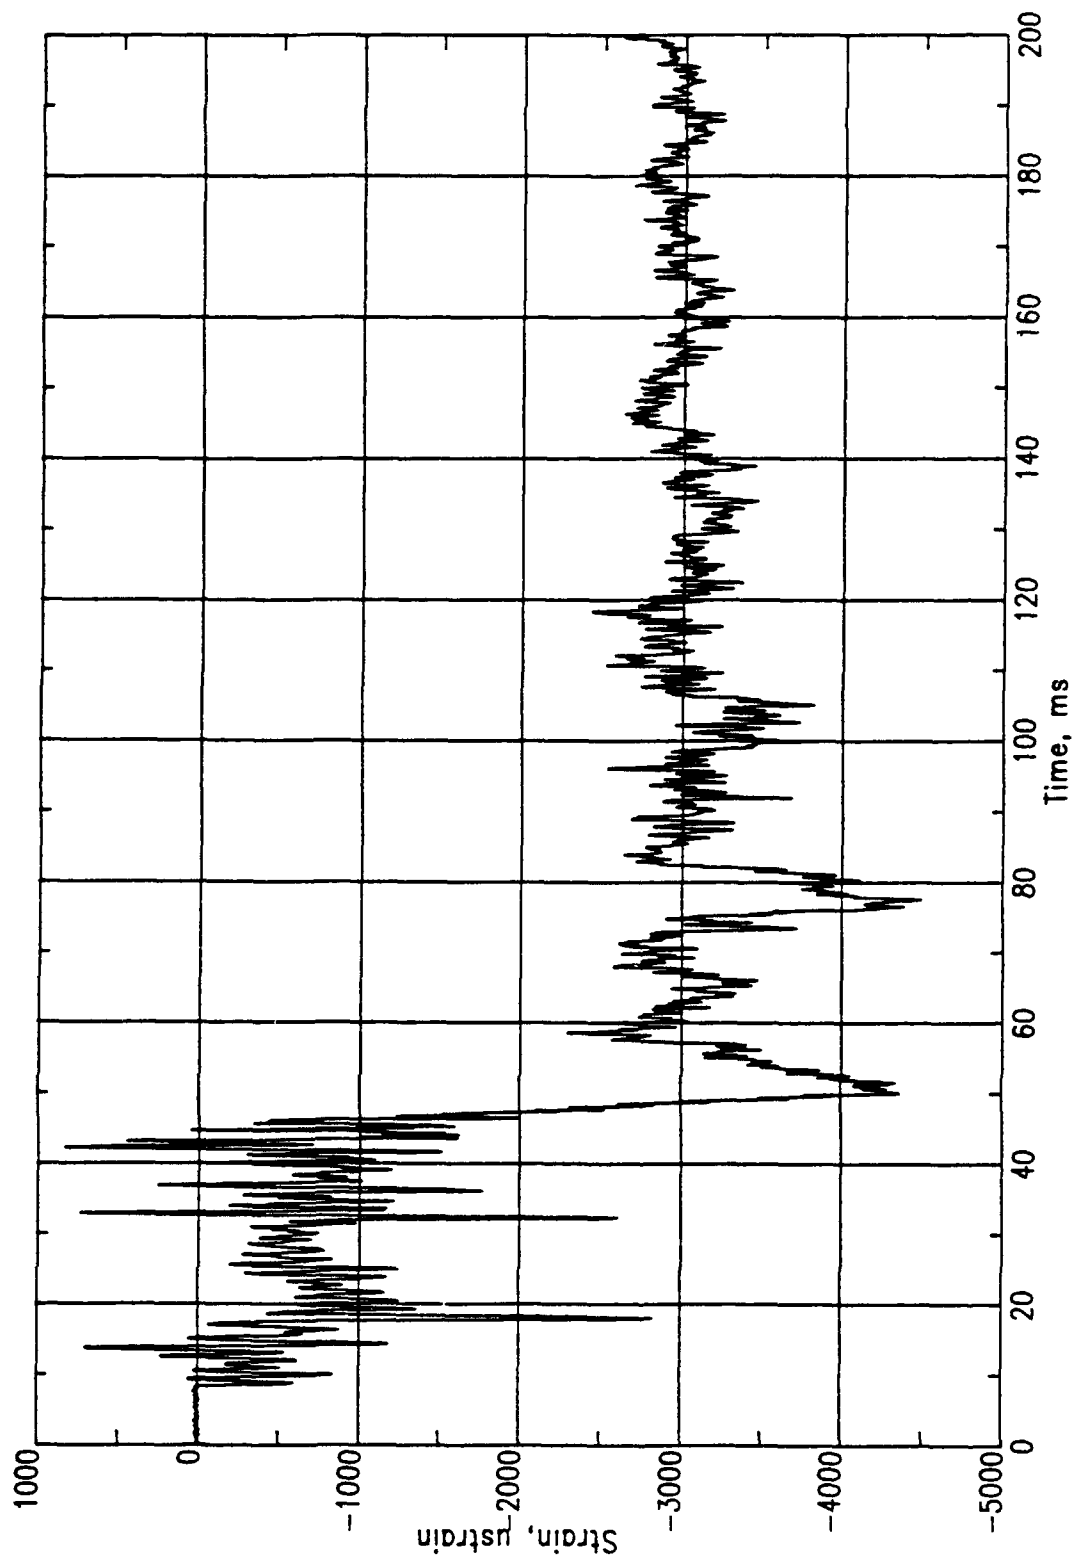
Figure 50. PAS-1, MN 3401.

Two pairs of strain gages were mounted about mid-height on the centerline of the door. One gage of each pair was mounted on the inner surface of the door and the other on the outer surface. One pair was oriented to measure vertical strains (MN 3402 and MN 3404) and the other to measure horizontal strains (MN 3401 and MN 3403). At about 22 ms, MN 3401 (Fig. 50) shows a horizontal tensile strain of 400 microstrain in the outside plate of the door. At the same time MN 3403 (Fig. 51) shows a tensile strain of 1200 microstrain in the inner plate. The horizontal tensile strains in the inner plate are not consistent with the outward bending of the door. A review of instrumentation setup records appears to eliminate polarity reversal as a cause, and the cause of this discrepancy has not yet been determined. At later times these two gages show tensile residual strains of 800 and 3000 microstrain, respectively.
